## Bathroom Leak Detection Report

**Customer name:** Example report  
**Work order:** JOB-101  
**Site address:** 1234 Smith St Smithville  
**Site contact:** J Smith  
**Date of inspection:** 13/2/2025

Carry out leak detection on property. Insured has reported water damage to the main bathroom.

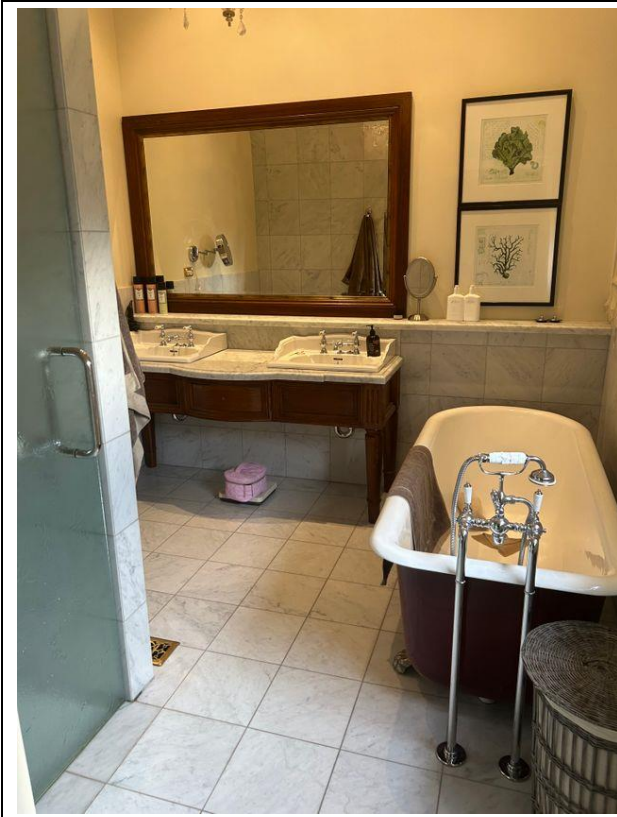
Ensuite overview

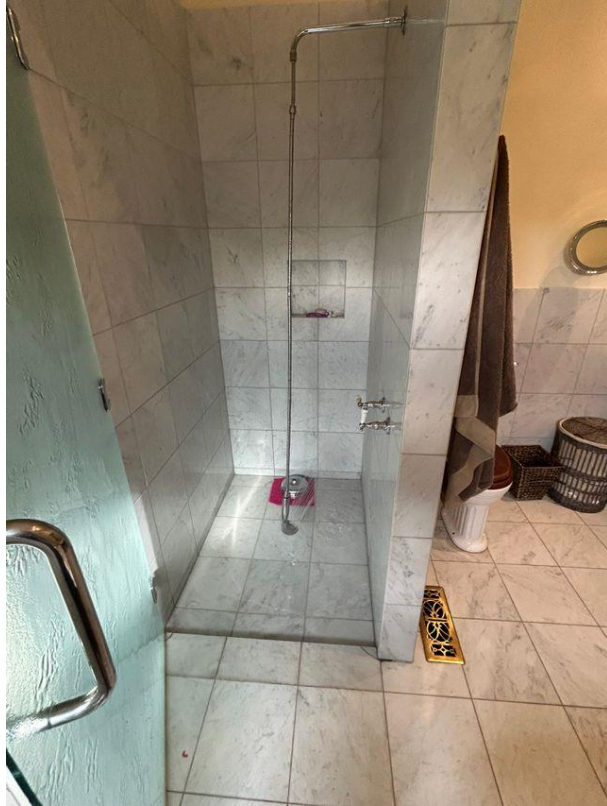
Shower recess overview

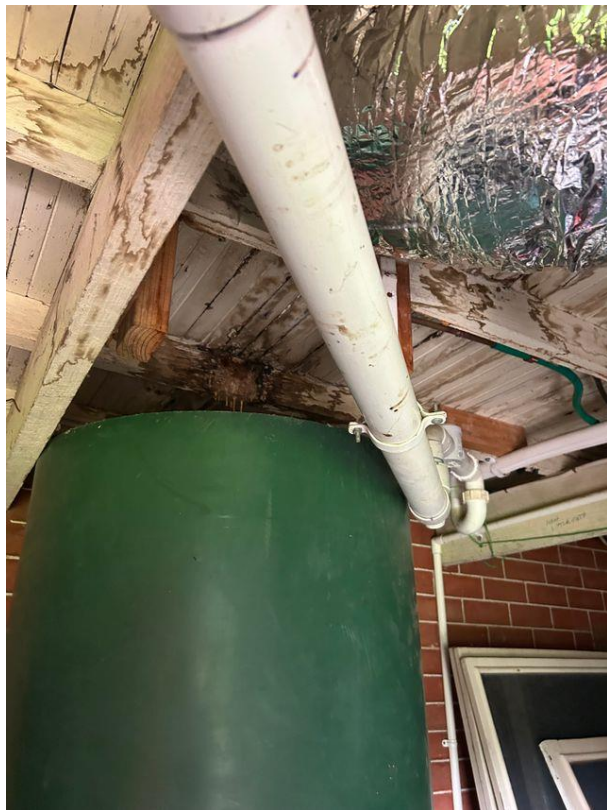
The site contact pointed out water damage to the timber flooring below the ensuite via access from a storage area under the house.

The water damage is consistent with a leaking shower screen and cracked floor tiles allowing water into the timber flooring below.

Damages below the shower recess

A builder is to be engaged to determine the best repair method for the cause of the leak to the shower screen and floor tiles and the damage

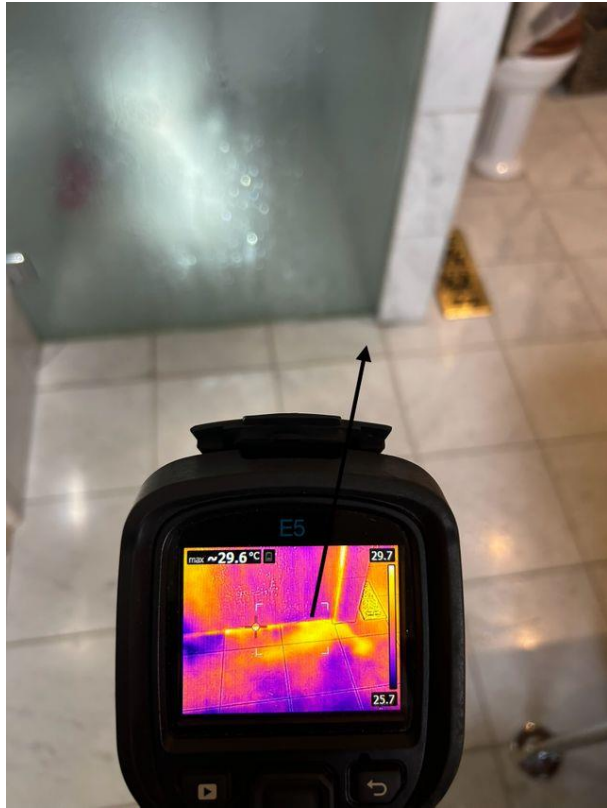
A leak detection to the ensuite has identified a leaking shower screen and cracked floor tiles adjacent to either corner of the shower recess.

Leaking shower screen identified with thermal imaging

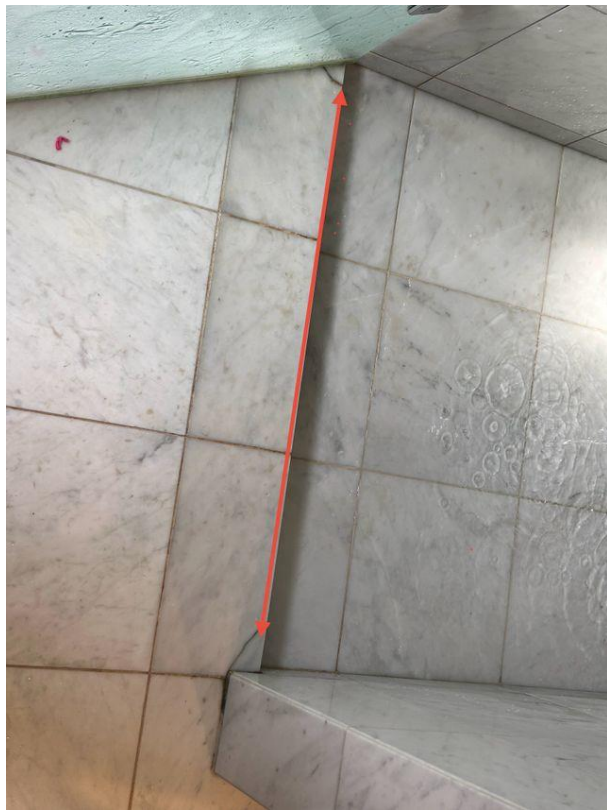
Cracked tiles adjacent to the shower screen and shower recess

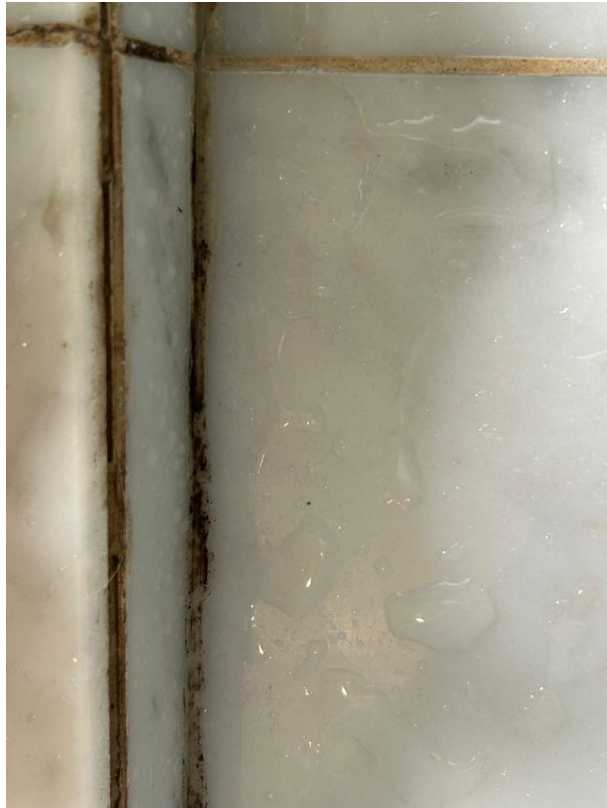
Aged tile grout and caulking to the shower recess

Age caulking and grout to the tiled shower recess

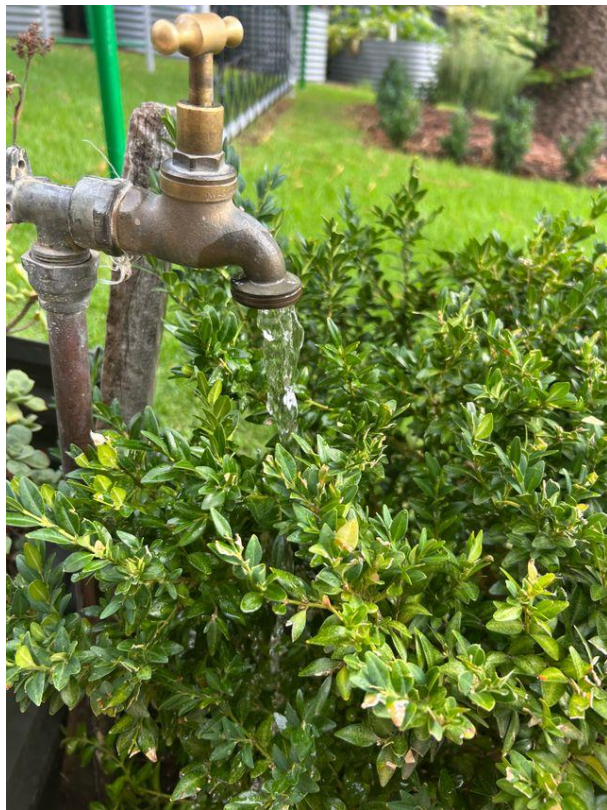
A pressure test to the main water supply was inconclusive during today's attendance as the water main did not fully isolate to carry out the correct test, however, the damage is not consistent with a leak from the water main.

Mains water and did not isolate during our attendance

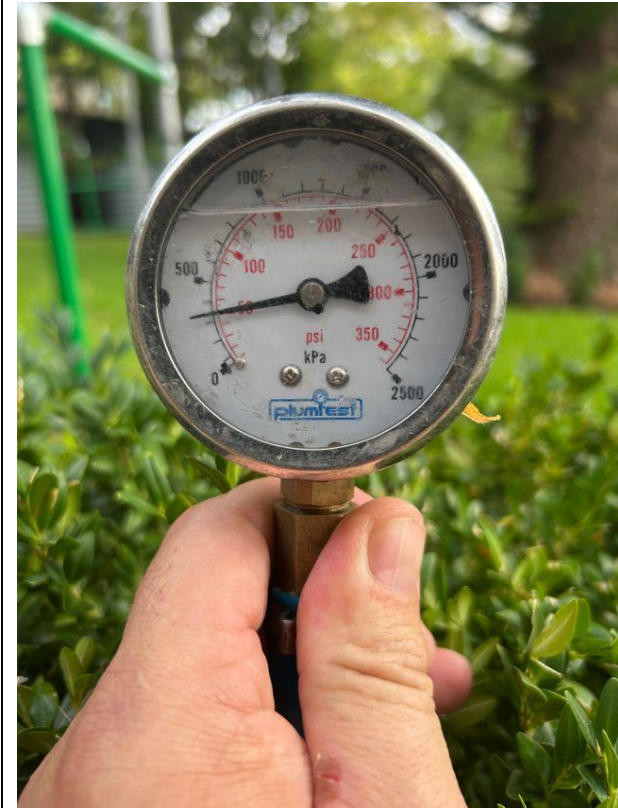
Attempted pressure test to the mains water supply in conclusive result

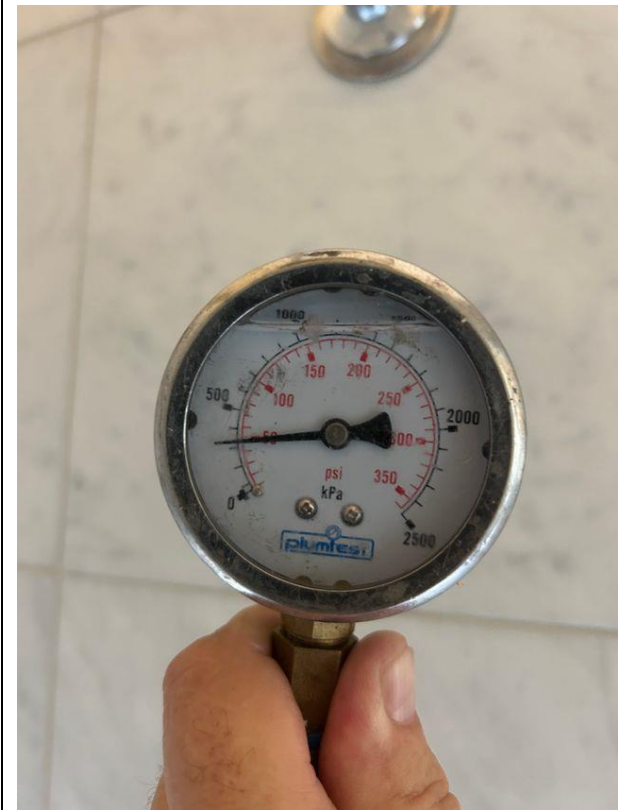
Process test to the shower breach has passed

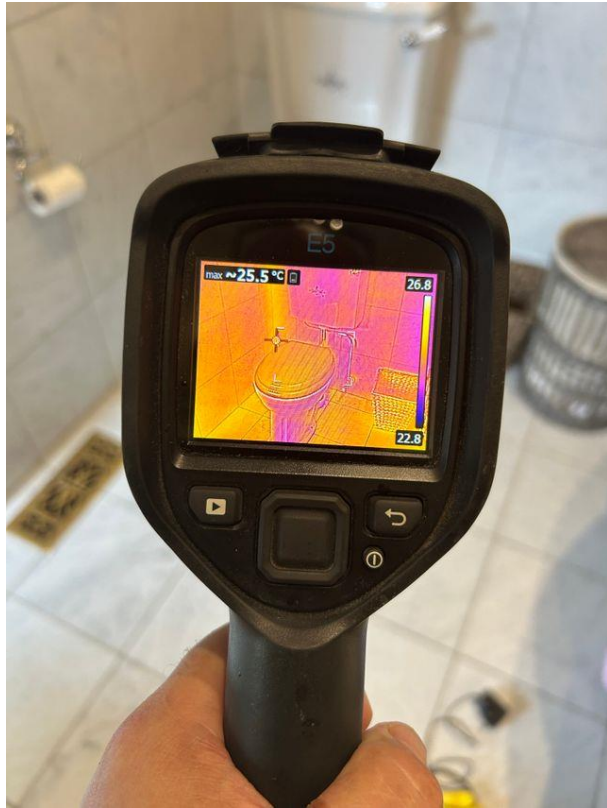
Testing to the toilet has passed

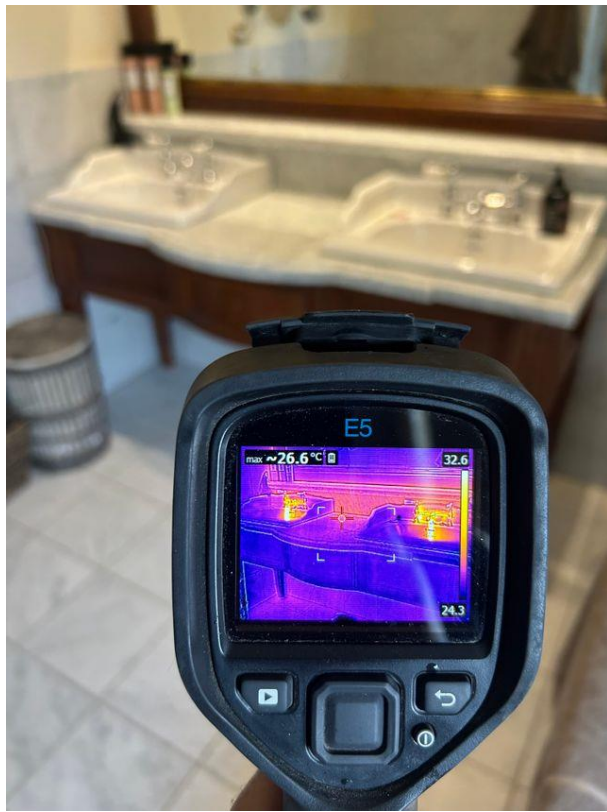
Testing to the vanities have passed

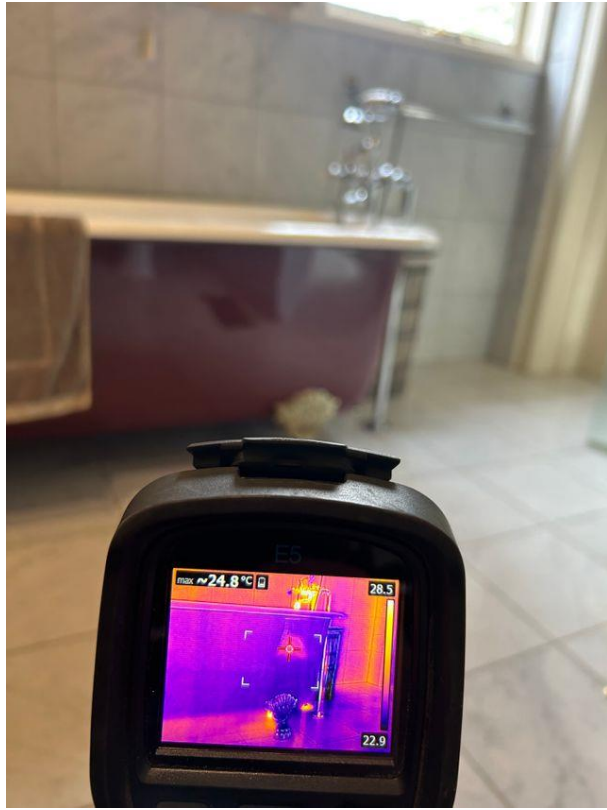
Testing to the bath has passed
