Roof Report

Customer name: Example report
Work order: JOB-101
Site address: 1234 Smith St Smithsville
Site contact: J Smith
Date of inspection: 21/1/2025

Roof report to assess for impact damage from hail storm. Please assess damage to HWS on roof and provide possible COD	
Leak detected:	No
Location of the leak:	No leak detected
Location of the damage:	Tiled roof penetrations
Extent of the damage:	Impact damage to the whirlybird and metal flue lead flashing

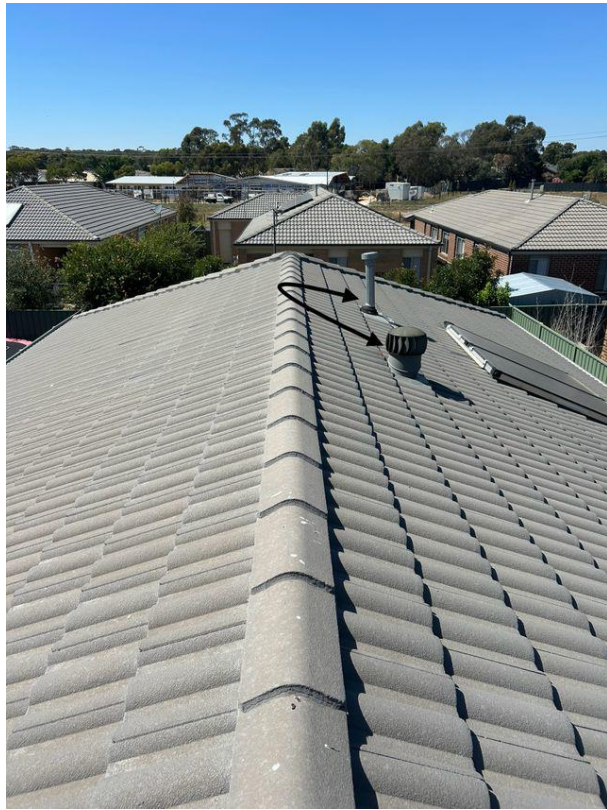
Roof overview and the area of damage

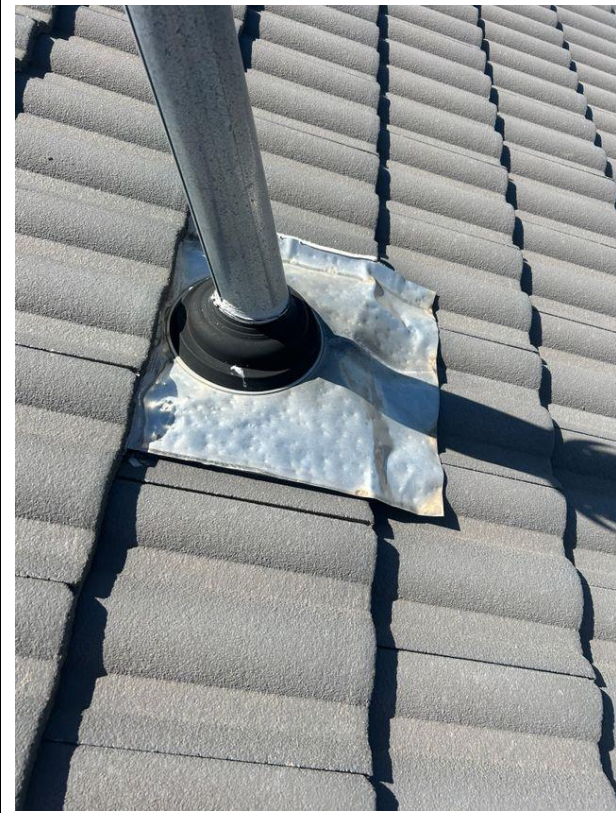
A roof inspection has identified impact damage to the whirlybird and the metal flue lead flashing.

The damage is consistent with hail impact.

Impact damage identified to the lead flashing

Replace the whirlybird and the lead flashing to the metal flue.

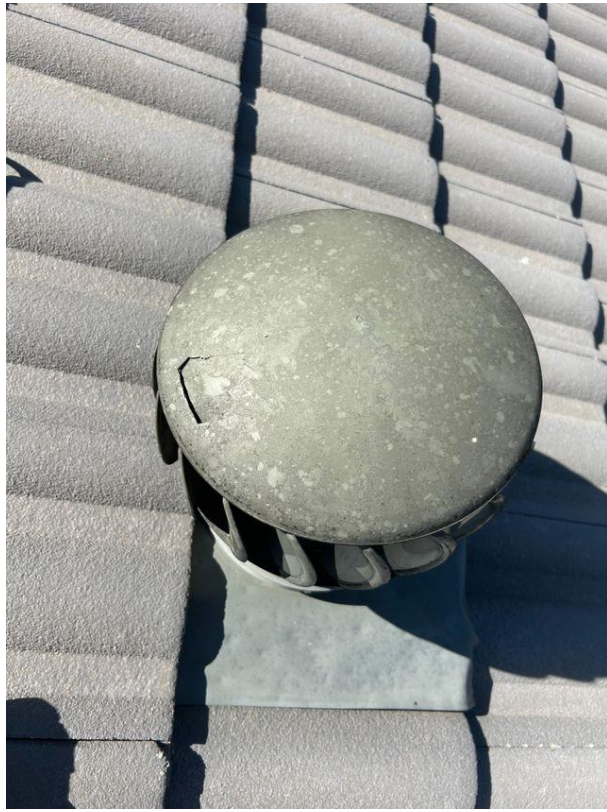
Impact damage identified to the whirlybird

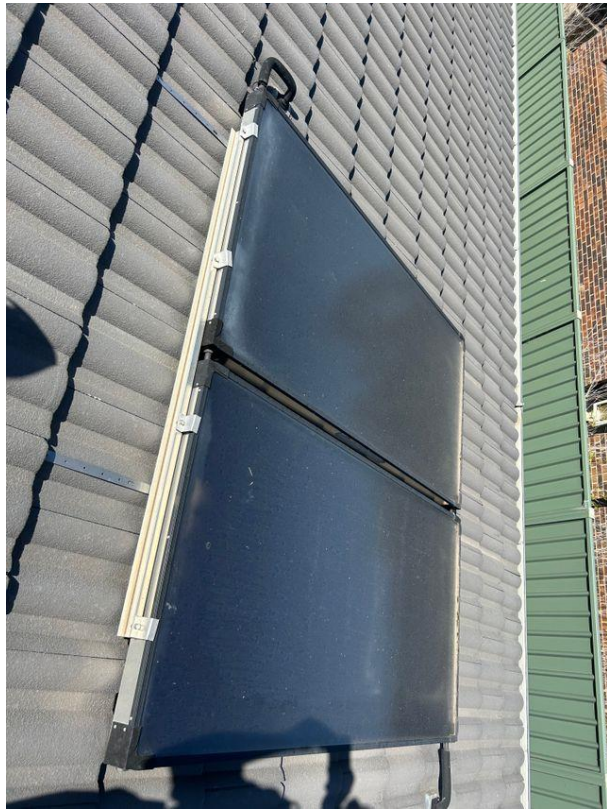
No damage to the solar identified

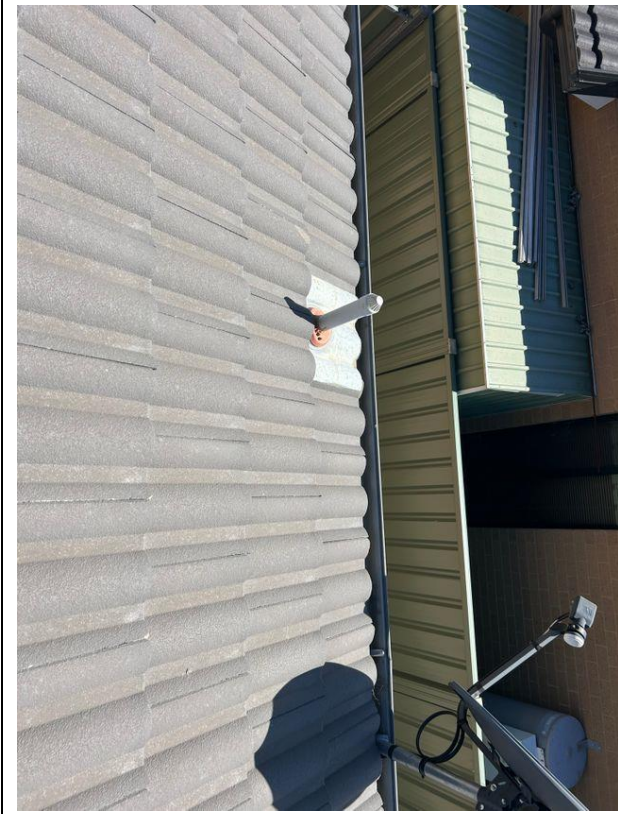
No damage to the vent
